# Final Report Coastal Assessment for Kahaluu Beach Park Planning

Kahaluu-Keauhou, Hawaii Island, Hawaii August 2021

### Kahalu'u Beach Park Structural Condition Assessment Kahaluu-Keauhou, Island of Hawaii, Hawaii

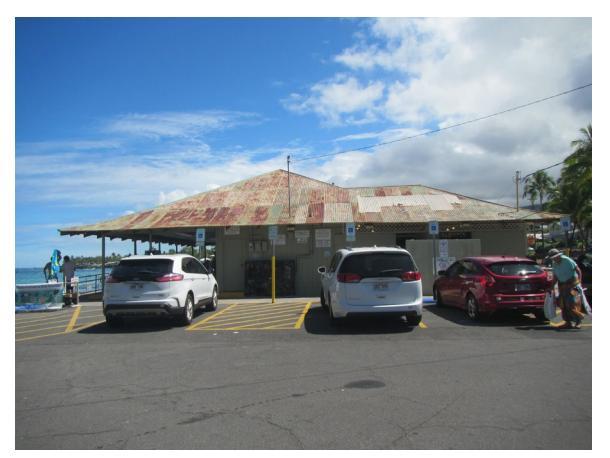
- Significant corrosion resulting in holes through the metal was observed in the roof panels (Photo 2). Some panels have been replaced.
- Significant termite deterioration and dry rot was observed at the 2x6 rafter tails (Photo 3) and perimeter beams (Photo 4).

Photo 2. Corroded and Replaced Roof Panels

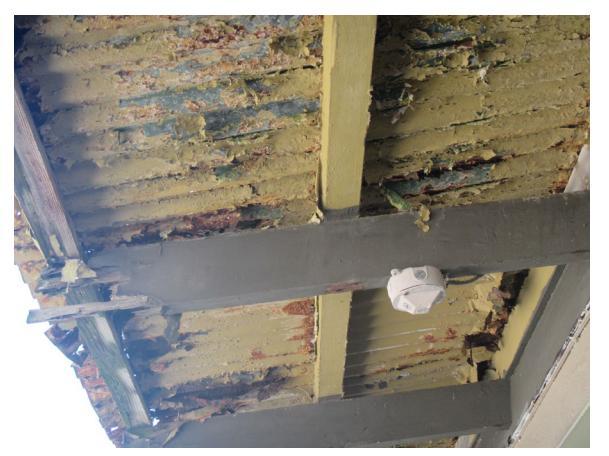
Photo 3. Deteriorated Eave Rafter

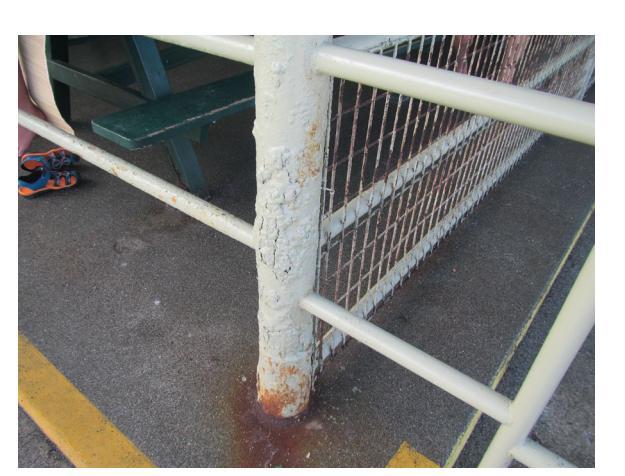
- Significant corrosion was observed in perimeter posts (Photo 5). The bases of several posts have been repaired (Photo 6).

Photo 5. Corroded Post

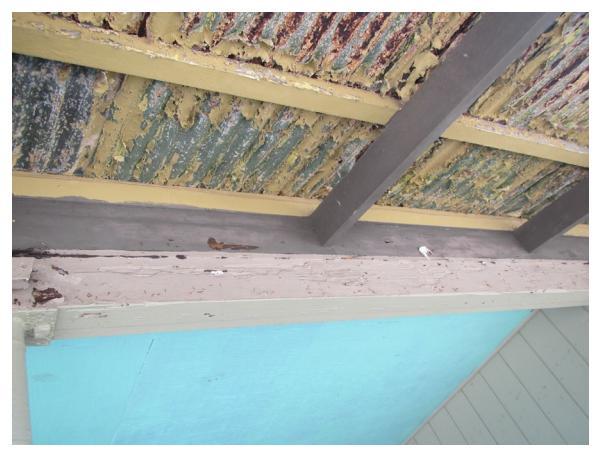
Photo 4. Deteriorated Beam

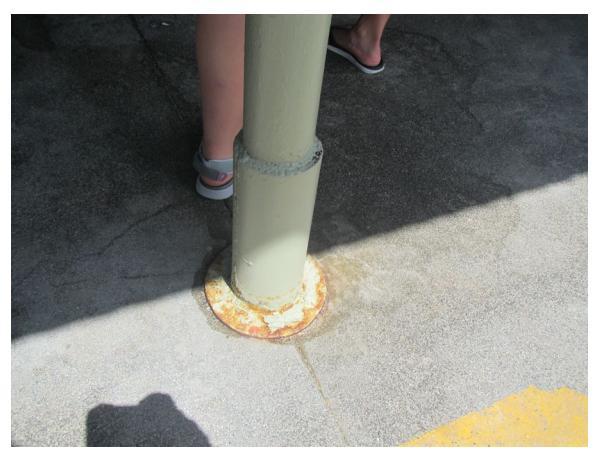
Photo 6. Repaired Post Base

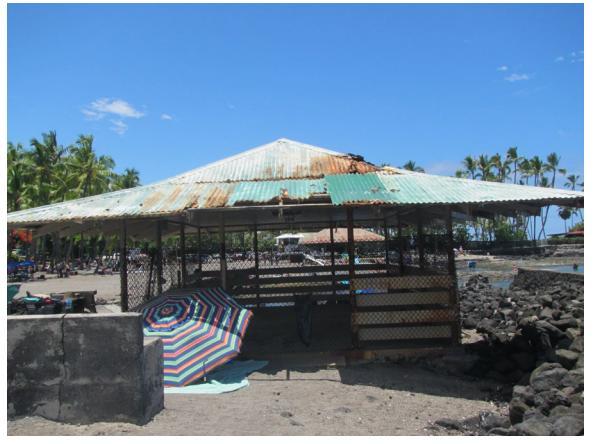
- Significant corrosion resulting in holes through the roof panels was observed (Photo 8).
- Severe dry rot deterioration was observed at the rafter tails and perimeter purlins (Photo 9).

Photo 8. Corroded Roof Panels

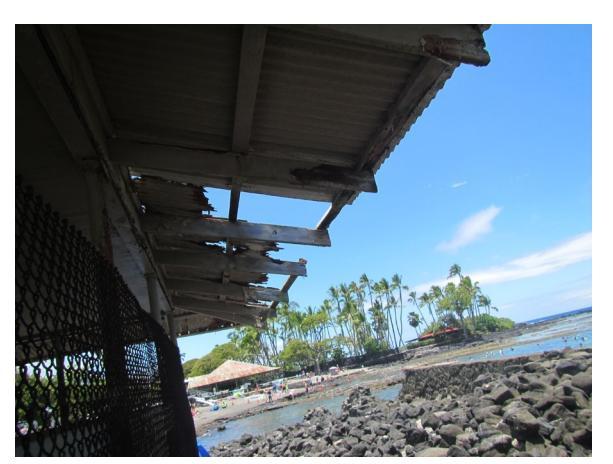
Photo 9. Deteriorated Eave Rafters

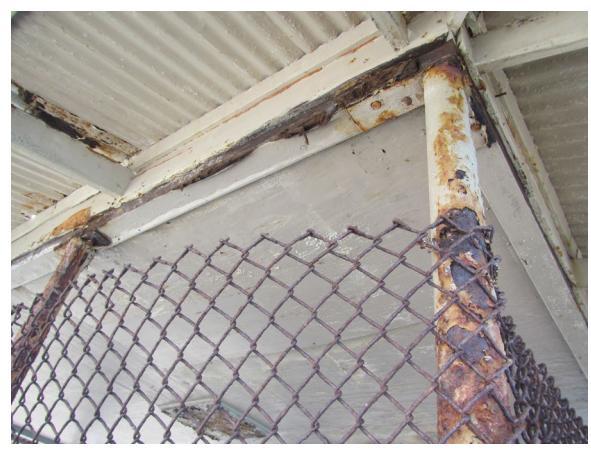
- Significant corrosion was observed in perimeter posts (Photo 10).
- Undermining of up to 1 to 2 ft deep was observed along west and south slab edges. The edges have been shored up with cobble (Photo 11).

Photo 10. Corroded Posts

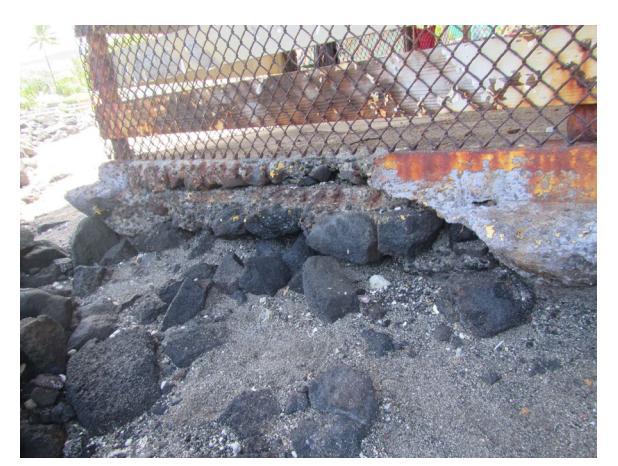
Photo 11. Slab Edge Undermining

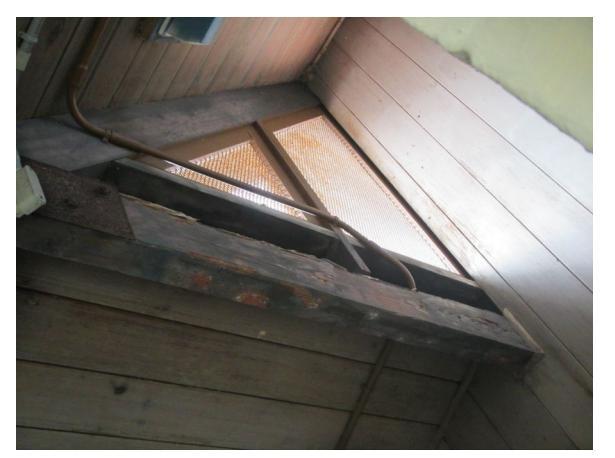
Photo 14. Termite Deteriorated Beam

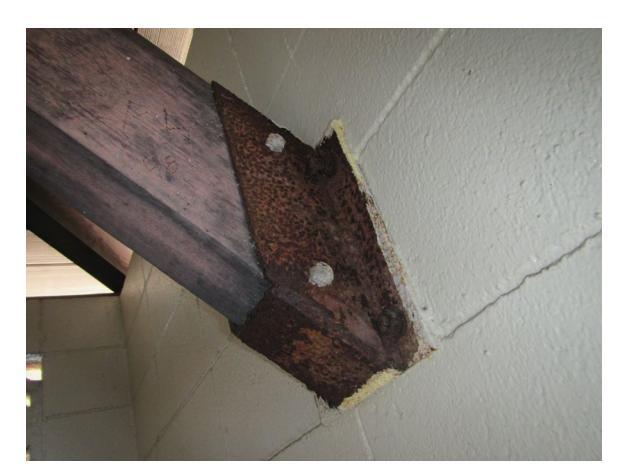
Photo 15. Corroded Connection

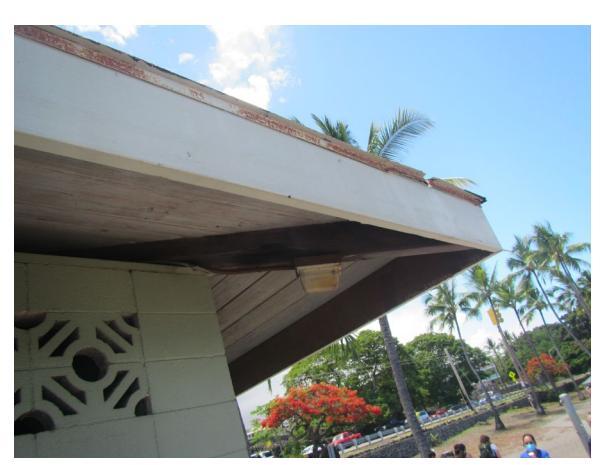
Photo 16. Corroded Roof Trim

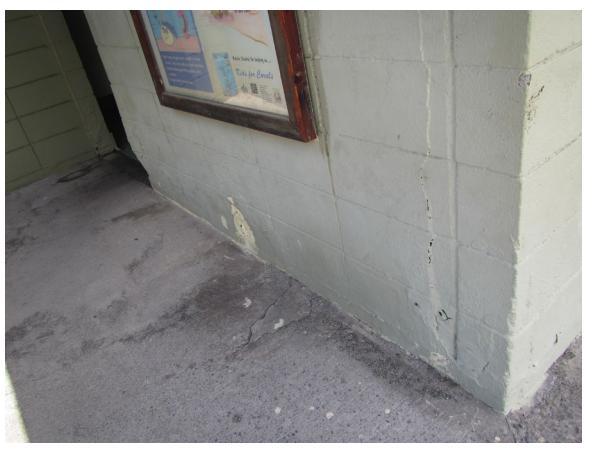
Photo 17. CMU Spalling

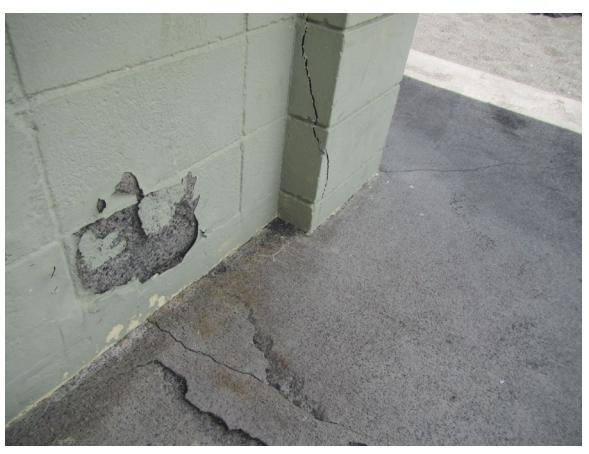
Photo 18. Deteriorated and Spalling CMU

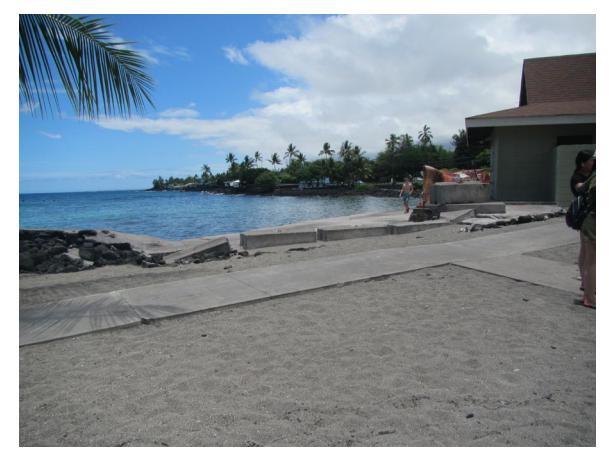
Photo 19. West Side Sinkhole

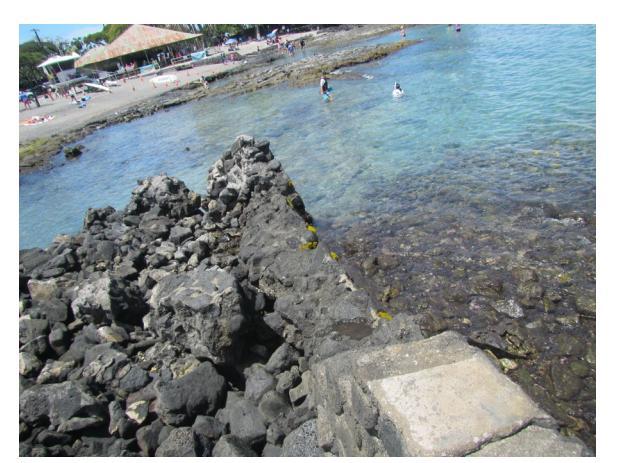
Photo 24. Partial Collapse of Top Section

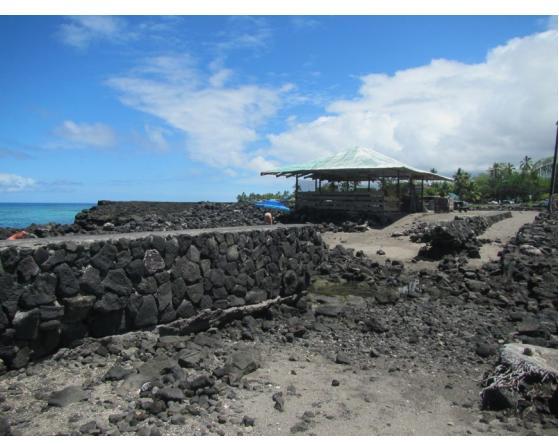
Photo 36. Undermining at Rear
