Pelekane Bay Watershed Restoration Project: 16 months later | Hawaii247.com

Special to Hawaii 24/7 by Barrie Moss | Outreach Coordinator

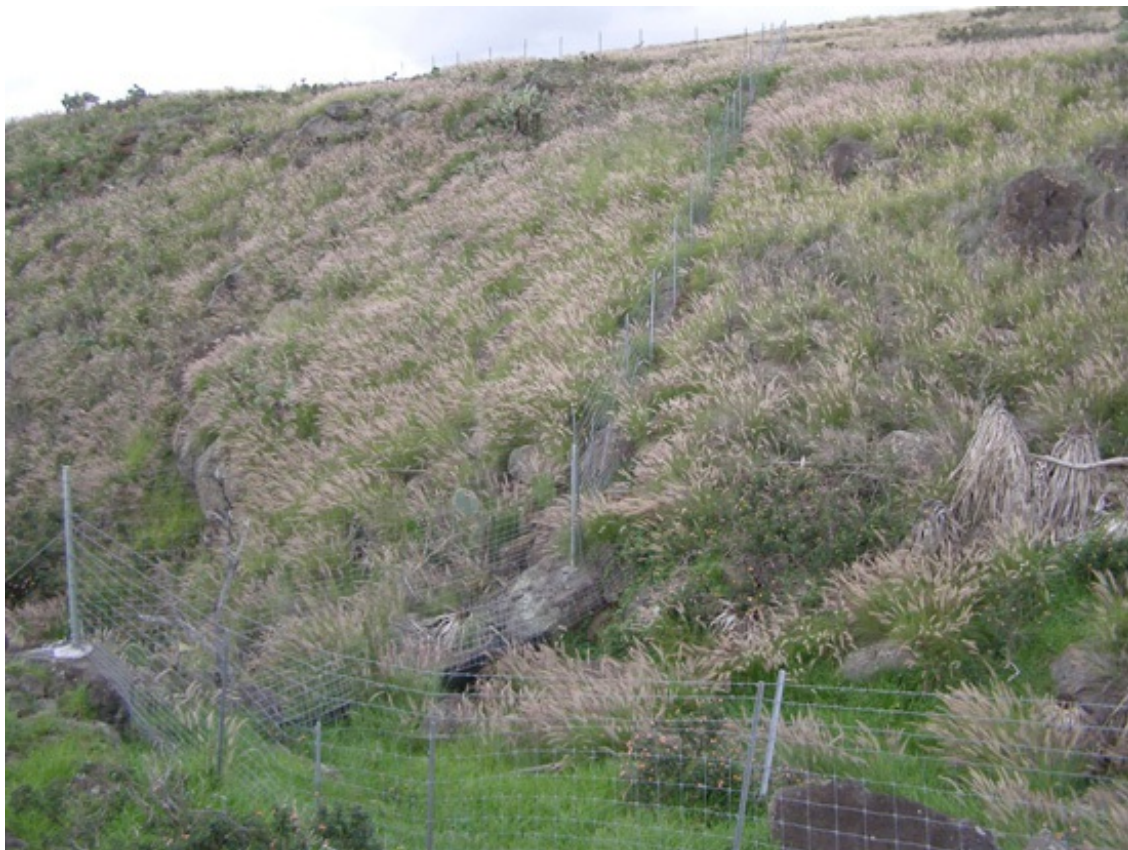
This fence had to go over stream crossings, rocky outcroppings and steep ascents:

The three strands of barbed wire on top are necessary as it is the only deterrent to the cattle who would otherwise just knock it right down.

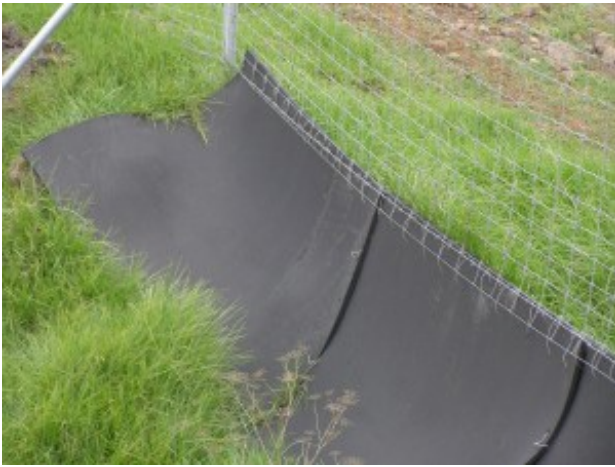
To manage the voids created by the fencing having to straddle a stream crossing, a very innovative technique was used:

These heavy rubber mats are looped to the fence and then to each other. They not only let the stream flow and debris pass under them during a rain, but remain an effective barrier to feral animals who are unable to scoot under them.

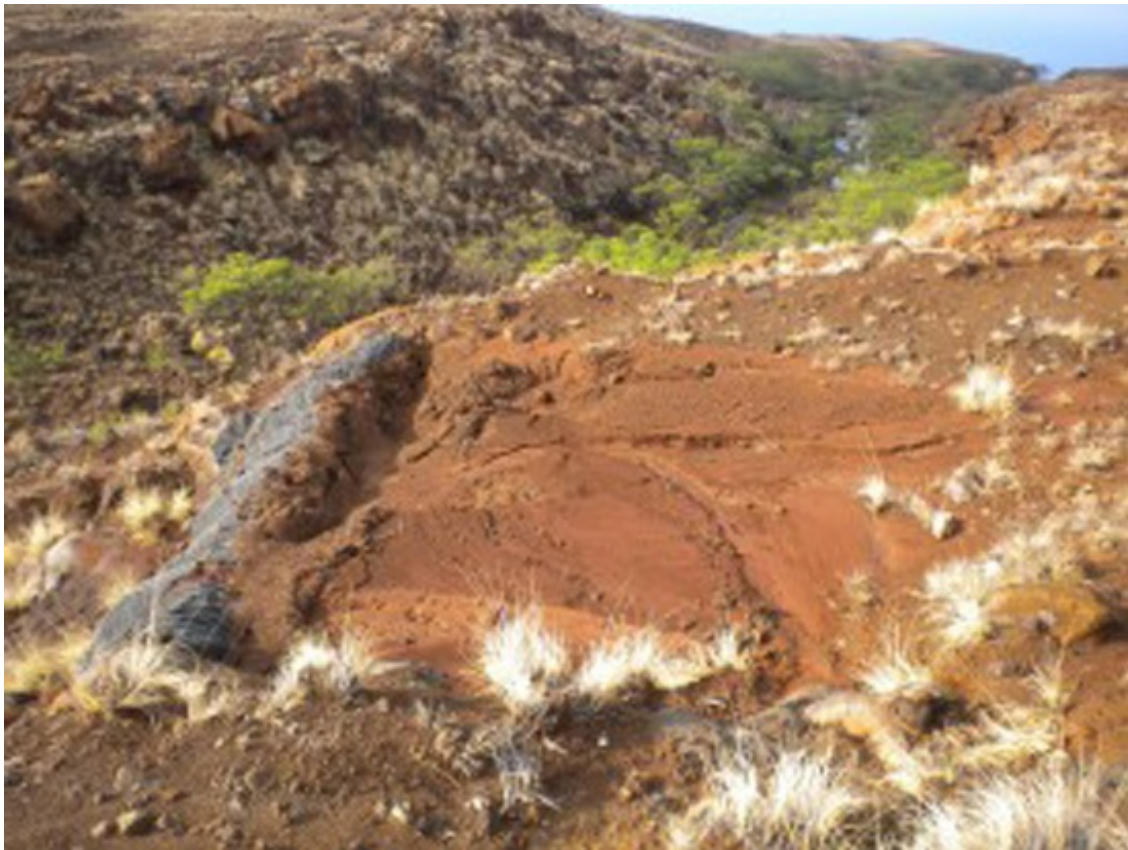
Here our sediment dam (rock, groundcloth and wire) has successfully ponded the flowing sediment that would have all flowed into Makeahua Stream below, ultimately ending up in Pelekane Bay:

We have had three storm events this year, each dropping significant moisture on this parched land. One in March and then one each in November and December. The Nov. 19 storm dropped 4 inches in one hour right in the middle of our watershed. The sediment dams that our crew built admirably weathered that stress-test.
