# Final Report Coastal Assessment for Kahaluu Beach Park Planning

Kahaluu-Keauhou, Hawaii Island, Hawaii August 2021

### Kahalu'u Beach Park Structural Condition Assessment Kahaluu-Keauhou, Island of Hawaii, Hawaii

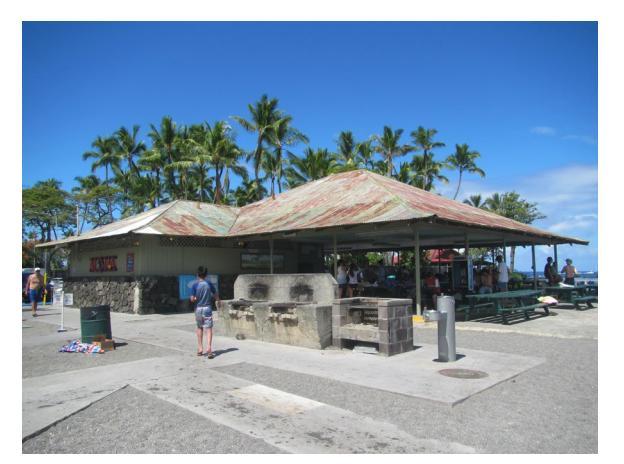
Photo 1. Northeast Elevation

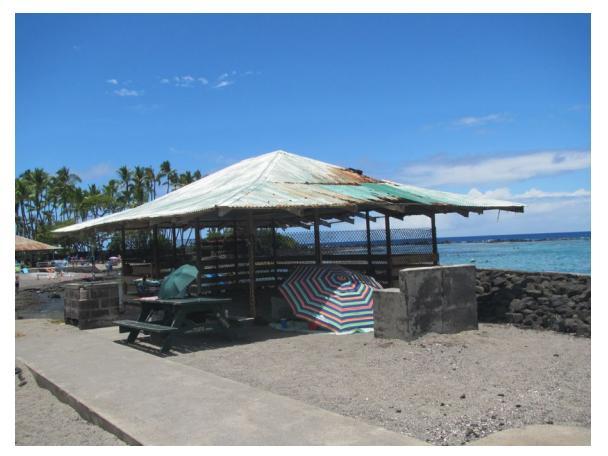
Photo 7. Northeast Elevation

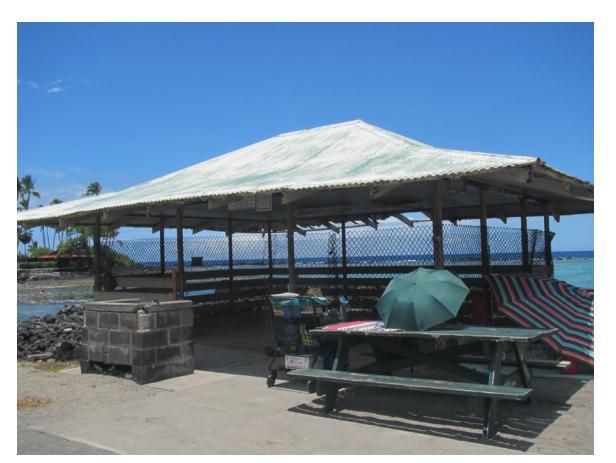
- The pavilion has been fenced off (Photo 12).

Photo 12. Fencing Around Pavilion

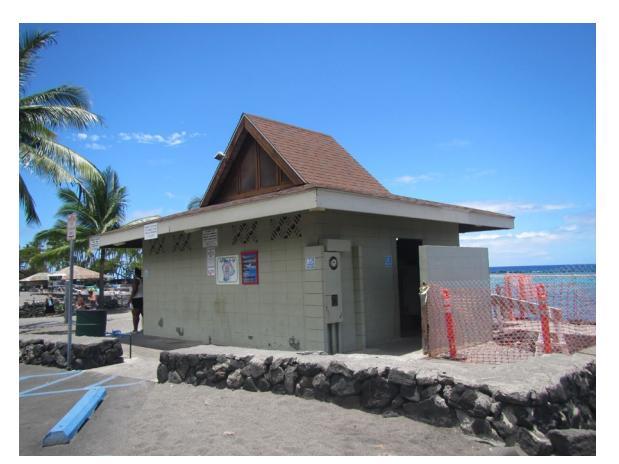
Photo 13. Northeast Elevation

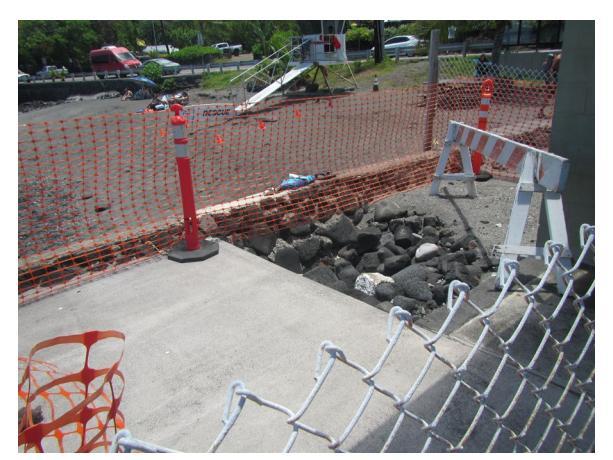
- The one-story building is about 22 ft by 22 ft in plan and is constructed of asphalt shingle covered wood planks spanning to 4x8 wood rafters at 6 ft on centers supported on 6 in. CMU walls bearing on a thickened edge concrete slab-on-grade. No hurricane clips are visible.
- Dryrot and termite deterioration was observed at roof framing (Photo 14).
- Roof framing connections (Photo 15) and roofing trim (Photo 16) are corroded.
- Spalling was visible along the base of all perimeter CMU walls (Photo 17). Some of the cracked and delaminated areas appear to be previously patched spalls that have spalled again.
- Deteriorated CMU faces were observed at the base of the east perimeter wall (Photo 18).
- Sinkholes and undermining of up to 10 ft in from the retaining wall west (Photo 19) and north (Photo 20) of the restroom was observed. The undermining may extend to the building.

Photo 20. North Side Sinkhole

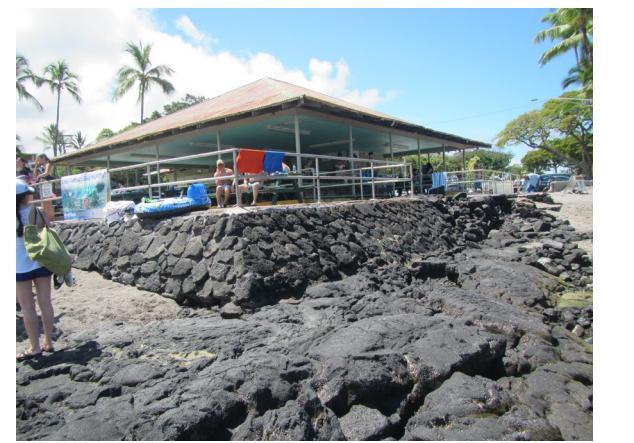
- CRM retaining walls up to a 3 ft maximum height support the retained soil and concrete lanai slabs at the west and north sides of the structure. The approximately 50 ft long west facing retaining wall appears to be bearing largely on rock while the approximately 40 ft long north facing wall is bearing on sand and cobbles.
- Undermining of up to one foot deep by six inches high was observed at isolated locations of the north facing retaining wall (Photo 22).

Photo 21. Northwest Elevation

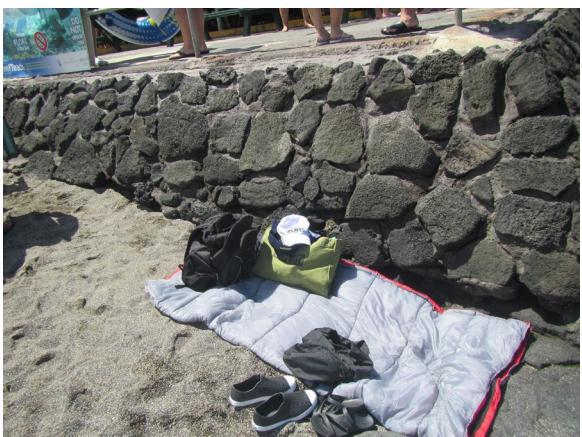
Photo 22. Undermining at Wall Toe

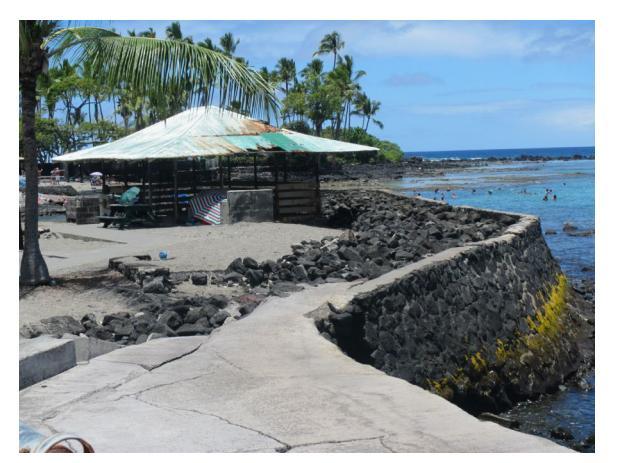
- The CRM seawall is approximately 180 ft long by about 7 to 8 ft high and extends from the south end of the north restroom wall, curving around the north pavilion to end about 60 ft south of the pavilion. The wall is approximately 18 in. at the top mortar cap with an approximate 1:12 front batter and 3:12 rear batter.
- An approximate 30 ft long by 4 ft high top section of wall at the south end has collapsed (Photo 24). The next 50 ft long middle section appears stable as it may be bearing on rock (Photo 25). The remaining 100 ft northern section has experienced some undermining of up to 1 to 3 ft in from the toe (Photo 26 and 27) with an isolated 4 ft long by 4 ft high partial collapse at the base (Photo 28), as this section of wall appears to bear largely on cobbles and sand. Cobble has been placed behind the wall apparently due to washout of sand substrate.

Photo 23. North Elevation

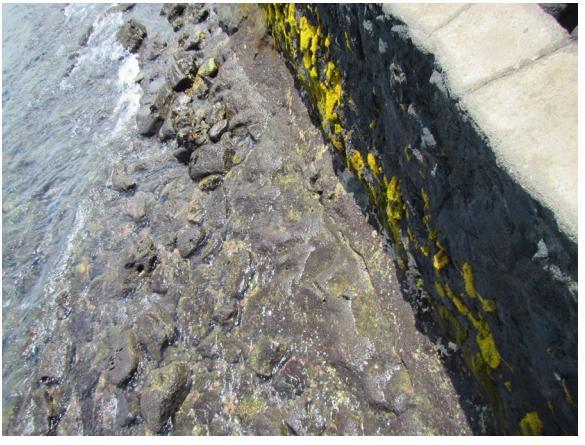
Photo 25. Non-undermined Section

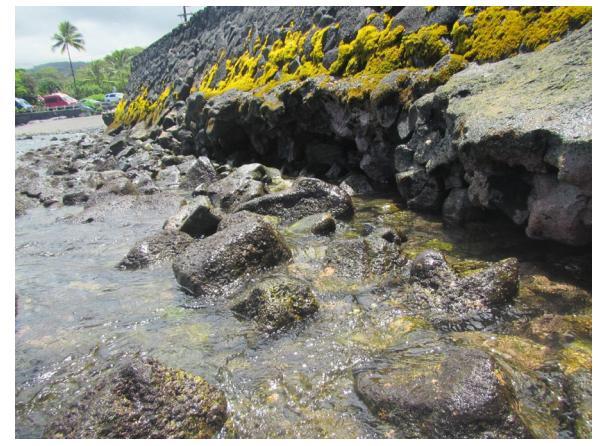
Photo 26. Undermined Section

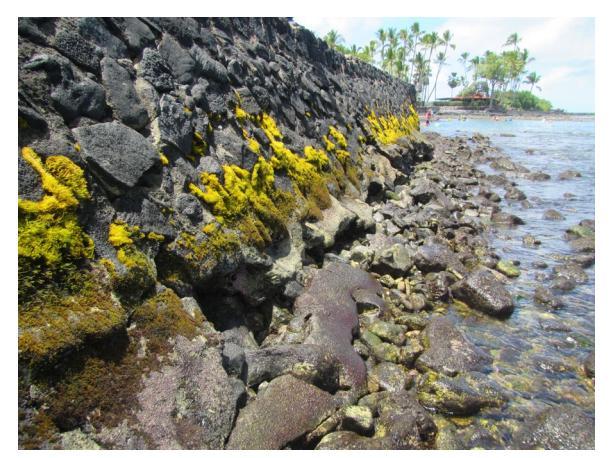
Photo 27. Undermined Section

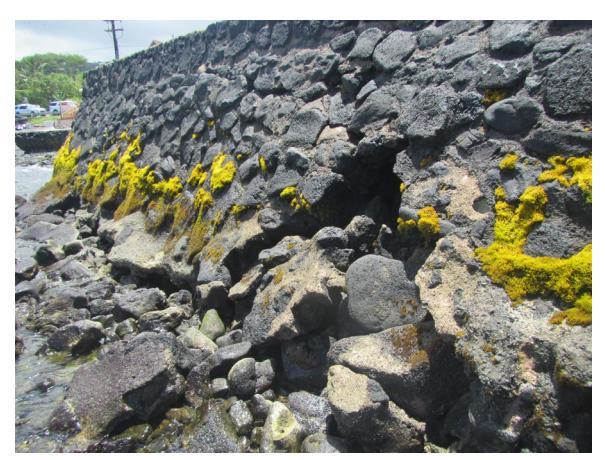
Photo 28. Partial Collapse at Base

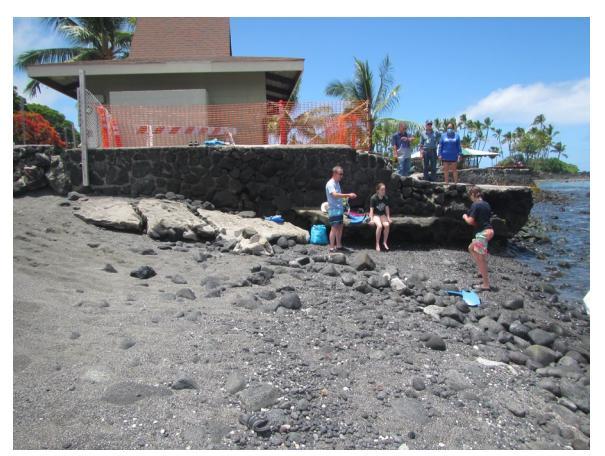
- The CRM seawall consists of an approximately 50 ft long by about 4 to 5 ft tall west facing section and approximately 30 ft long by 7 ft high north facing section. The walls generally appear to be bearing on sand and cobbles.
- The west facing section has rotated out to create a reverse batter of between 2:12 at the middle section to more than 4:12 at the ends (Photo 30). The north facing wall is undermined with the undermining extending 1 to 2 ft in from the face (Photo 31). Sinkholes are visible behind the walls and the northwest corner and south end are partially collapsed (Photo 32). Portions of concrete pavement behind the walls are likely undermined.

Photo 29. North Elevation

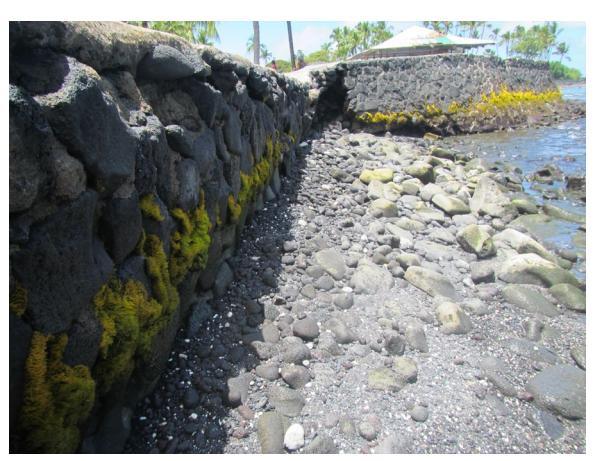
Photo 30. Outward Rotation of West Wall

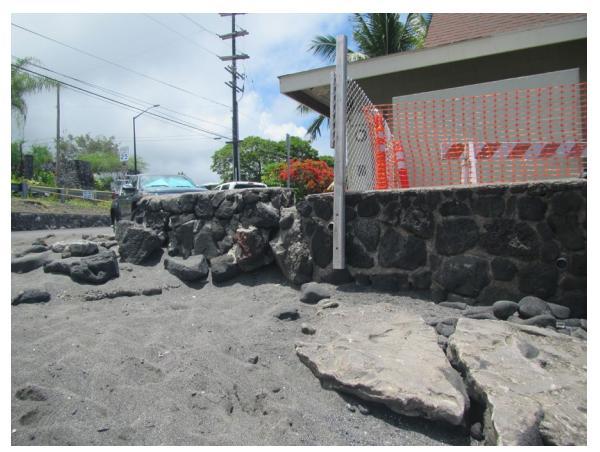
Photo 31. Undermining at North Wall

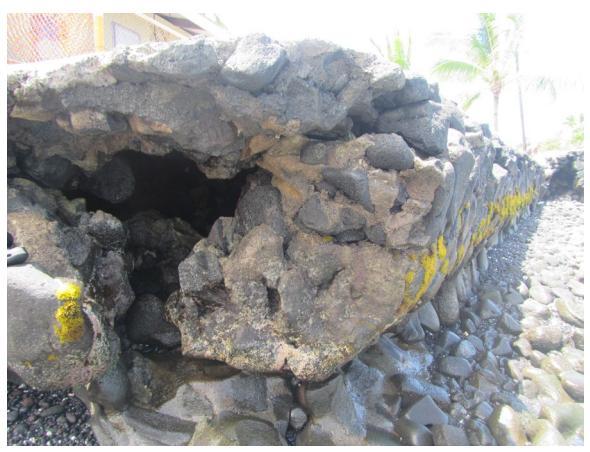
Photo 32. Partial Collapse at Both Ends

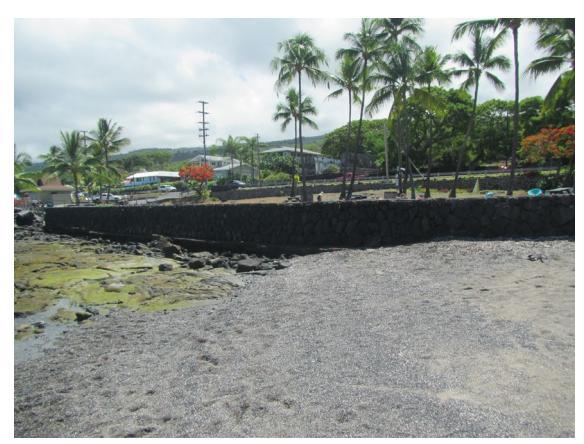
- The CRM seawall is approximately 250 ft long by 3 to 4 ft tall and 2½ ft wide at the top with no significant front or rear batter. The wall appears to bear largely on sand and cobble.
- An approximate 40 ft portion of wall fronting the pond has collapsed (Photo 34).

Photo 33. West Elevation

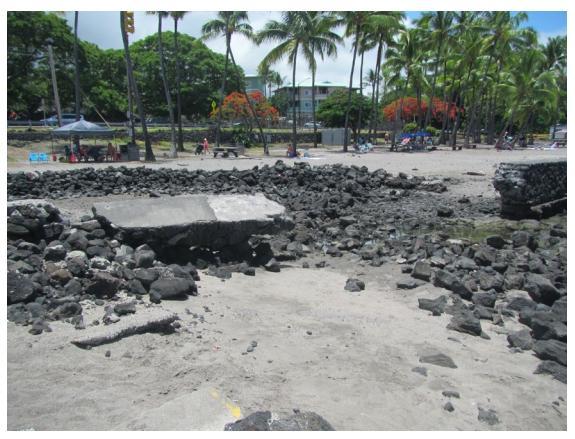
Photo 34. Collapsed Section

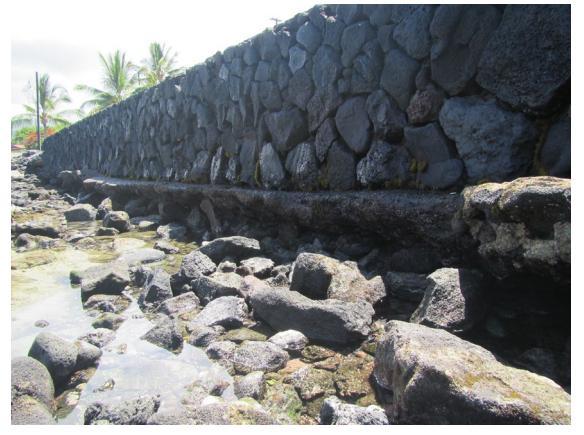
• An approximate 100 ft long portion to the south of the collapse portion is significantly undermined (Photos 35 and 36).

Photo 35. Undermining at Front Toe
